CERCLA Site Inspection

Levin-Richmond Terminal Corp.  
Parr Canal Site  
8th Street and Wright Avenue  
Richmond, CA 94804  
Contra Costa County

Purpose: CERCLA Site Inspection

Date of Inspection: August 14, 1986

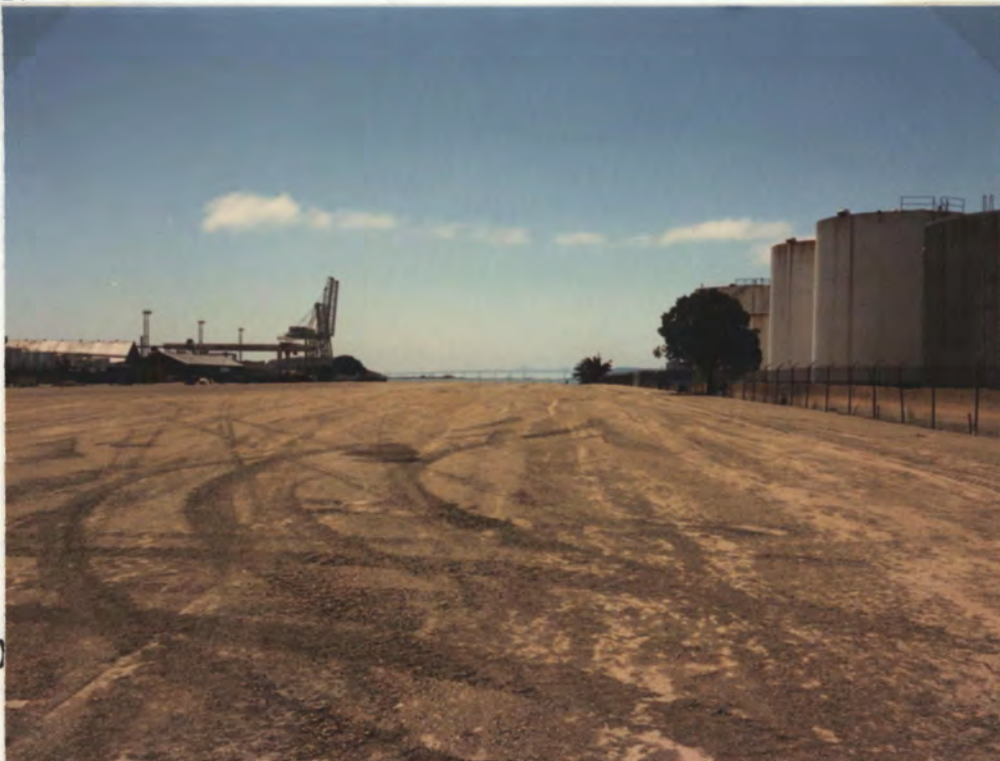
DESCRIPTION: Picture taken from entrance gate in northwest corner of lot. Time Oil tank farm on right.

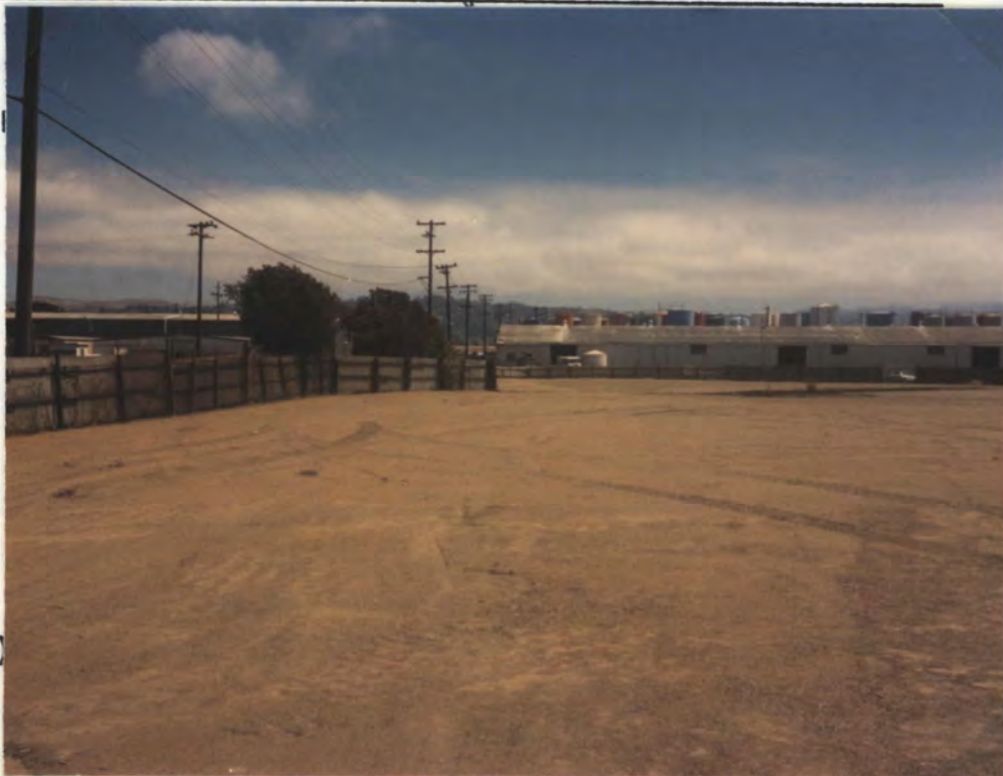
DESCRIPTION: Picture taken from northwest corner of lot. Wright Avenue runs parallel on left, End of Canal in middle on right.

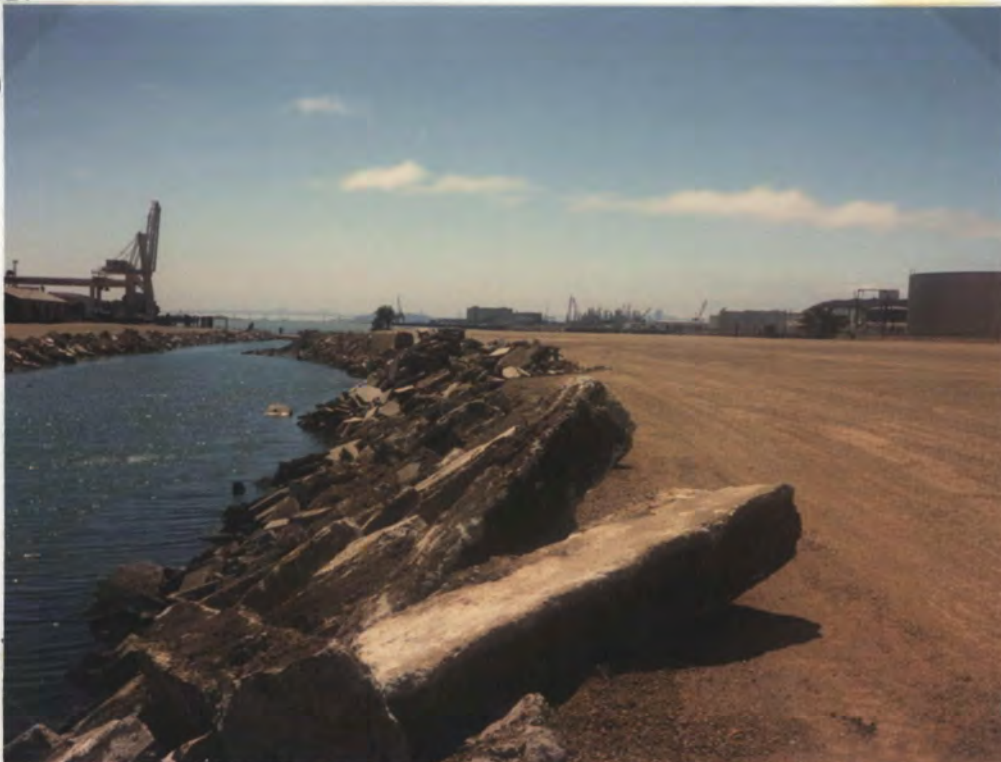
DESCRIPTION: View along Parr Canal towards Harbor Channel and San Francisco Bay. Notice recent placement of riprap (unfinished).

The embankment areas along the side of the Canal will be protected from erosion by the placement of riprap. The cover system will be inspected on a monthly basis. The four existing groundwater monitor wells on the east side of the site, and four new wells to be constructed on the west side of the site will be monitored semi-annually for the first three years and then, depending on the results of these samplings, annually for the following two years. If monitoring continues to show no contamination at the end of five years, monitoring will be discontinued.

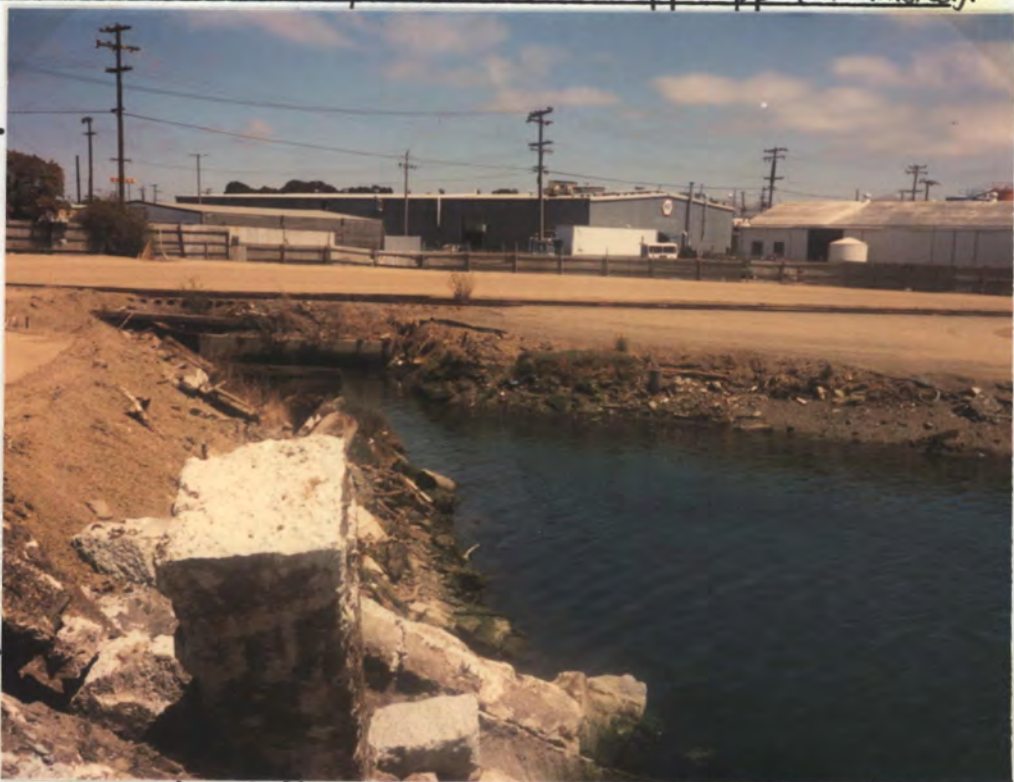
DESCRIPTION: View of north end of Parr Canal. Notice: riprap, storm sewer outfall, railroad spur, and geotextile membrane under crushed rock.
